# Common Failures in Hydraulic Kaplan Turbine Blades and Practical Solutions

**Abstract:** Kaplan turbines, as one of the well-known hydraulic turbines, are generally utilized worldwide for low-head and high-flow conditions. Any failure in each of the turbine components can result in long-term downtime and high repair costs. In a particular case, if other parts are damaged due to the impact of the broken blades (e.g., the main shaft of the turbine), the whole power plant may be shut down. On the other hand, further research on the primary causes of failures in turbines can help improve the present failure evaluation methodologies in power plants. Hence, the main objective of this paper is to present the major causes of Kaplan turbine failures to prevent excessive damage to the equipment and provide practical solutions for them. In general, turbines are mainly subjected to both Internal Object Damage (IOD) and Foreign Object Damage (FOD). Accordingly, this paper presents a state-of-the-art review of Kaplan turbine failures related to material and physical defects, deficiencies in design, deficits in manufacturing and assembly processes, corrosion failures, fatigue failure, cavitati

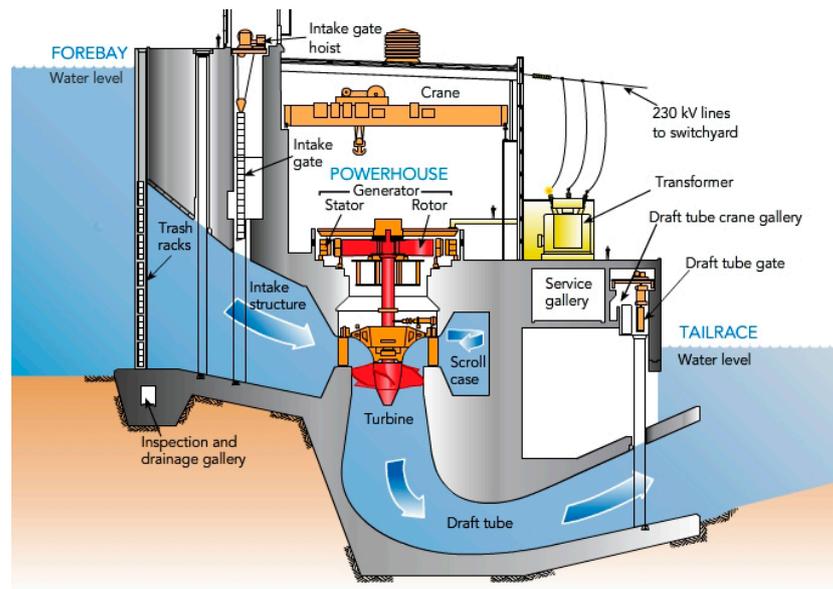
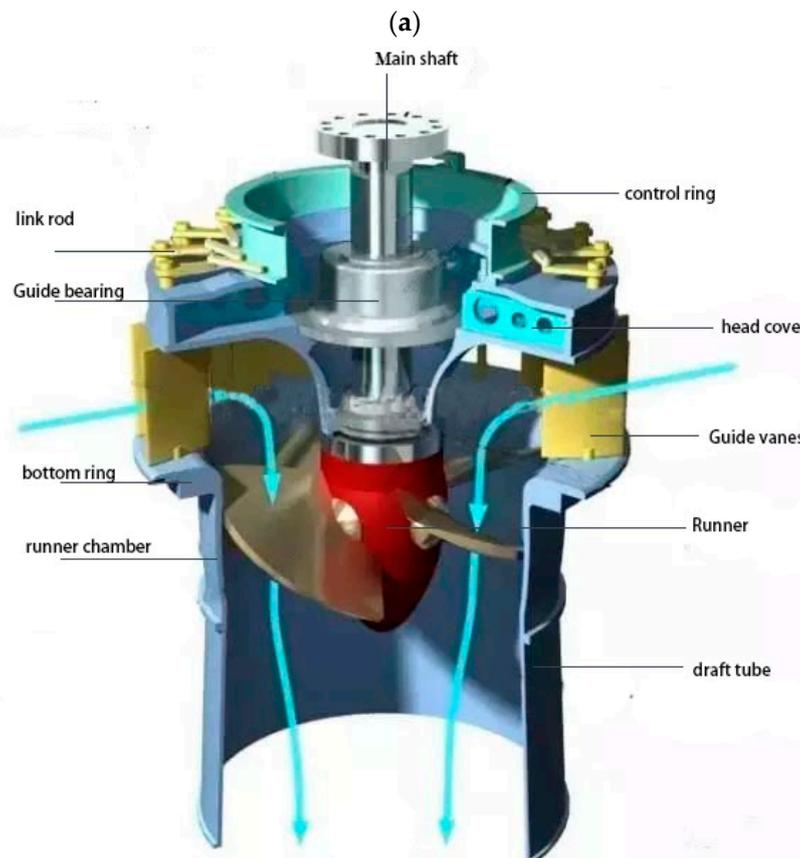
Figure 1. (a) Side view of the hydropower plant and (b) the main parts of Kaplan turbine [42].

The Kaplan turbine is classified as a reaction turbine, and it is a propeller-type water turbine that has movable edges; Viktor Kaplan, an Austrian teacher, invented it in 1913. The operational head of water ranges from 10 to 70 m and the power generation from 5 to 200 MW [39]. From its apparent head of 34.65 m, the Kaplan turbine foundation is said to provide the highest power, and each of the ten 4.8 m wide sprinters at the Tacoma Power Plant (Venezuela) will produce 235 MW. Kaplan turbines are currently more popular due to their dual regulating function, which allows them to operate under a variety of hydraulic circumstances. Kaplan turbines can save more time and resources in the construction of power plants than higher-head turbines since they have a smaller excavation depth and require less earth excavation [40,41]. Figure 1 depicts a side view of the hydropower plant and the main parts of the Kaplan turbine [42]. The main parts of the Kaplan turbine are: spiral casings; stay ring and stay vanes; guide vanes; runner blades; and draft tube.

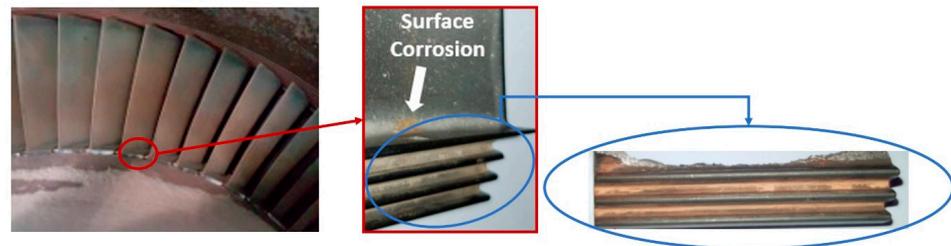
**Figure 3.** Failure due to the corrosion of Kaplan turbine blades [94].

The corrosion phenomenon is abundantly seen in industrial parts such as intakes, penstocks, isolation valves, scroll cases, wicket gates, turbine runners, draft tubes, spill ways, and radial gates. Figure 3 illustrates this destructive phenomenon in turbine blades that led to failure [94]. Often, the first point of attack is at or near the Heat Affected Zone (HAZ) adjacent to the weld regions. The corrosion resistance of a material is perhaps the most critical aspect in determining whether it is suitable for a certain application or not. In practice, corrosion rate can be calculated using thickness data gathered at more than two separate times [95].

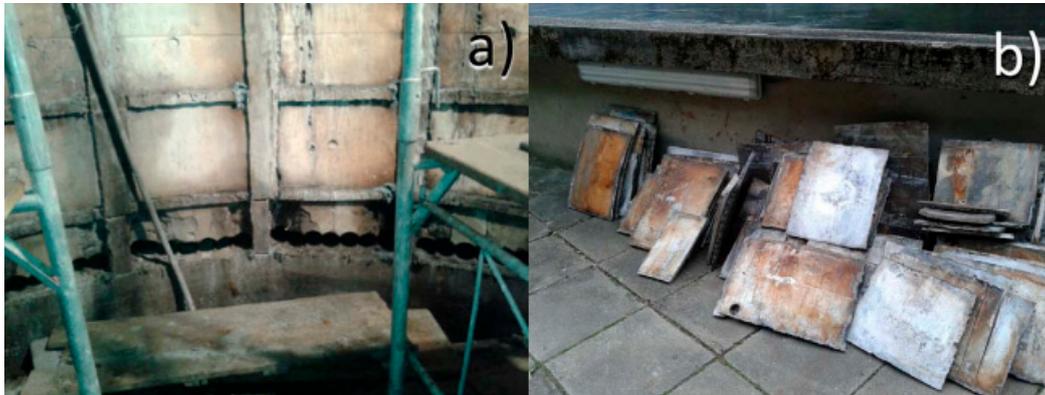
**Figure 4.** (a) Replacement of draft tube and (b) individual sheets after removal from the draft tube [99].

Uniform corrosion is a type of corrosive attack in which the damaged areas are evenly distributed across the attacked material. Because the assault happens throughout the entire exposed surface, uniform corrosion can quickly leave vast amounts of material unusable [96]. The corrosion of steel structures in freshwater flows is a significant concern in hydraulic engineering. The high level of dissolved oxygen in water, its hardness, and activity, which are governed by the hydrogen-ion concentration (PH), and the effect of the products of living fouling organisms' physiological activity, determine the corrosion mechanism. The penstock is used to drain water from the source to the powerhouse hydro turbine. This is the most critical portion of micro hydro, because it transfers the water's potential energy into kinetic energy [97]. Another essential part of the Kaplan turbine is the draft tube, which connects the water turbine exhaust to the tailrace. The water canal that transports the water out of the turbine is known as the tailrace. It transfers the kinetic energy of the water at the turbine's outflow to static pressure and is normally found near the turbine outlet [98]. The most typical type of wear that attacks these sections of hydro turbines is uniform corrosion. Stainless steels, which are used to make hydropower plant components, are complex alloys that contain not only Cr and Ni as their main alloying elements, but also Mo, Mn, C, N, Ti, and other elements. These elements can precipitate in the form of secondary particles, such as carbides, nitrides, and sulfides, depending on their solubility. The existence of such secondary particles in the microstructure can have a significant impact on the final component's mechanical characteristics and corrosion resistance [99–102]. An example of this is the damage to a 48 MW Kaplan draft tube at a hydropower plant in the Czech Republic. In this turbine, flow is entered through a spiral casing, passes through a runner, and finally leaves through the draft tube, which transforms dynamic pressure to static pressure [99]. The user inspects the draft tube, which is a steel weldment embedded in reinforced concrete, yearly. After a visual inspection indicated cracks, a non-destructive testing approach was used to validate their presence. During the repair process of the draft tube, every high-temperature activity (i.e., welding and grinding) produced fracture progression. Horynová et al. have performed a basic metallographic analysis, which revealed the presence of an intermediate phase that lowered the material's ductility. Heat treatment has been used to eliminate this phase, but it is precipitated again during the welding process [99]. The failed parts of the draft tube were

replaced as illustrated in Figure 4, and the failed material was sent to a laboratory for additional analysis to determine the cause of the failure and its mechanism.

After performing a comprehensive analysis of the chemical composition and studying the microstructure of the failed parts, they reported that the failure was due to intercrystallite corrosion resulting from unsuitable chemical composition and microstructure [99]. In this case, replacing the failed parts and using protective coatings is the most common solution for corrosion control. Isolating the reactive structural elements from environmental corrosives is the main function of the protective coatings, and these materials occupy a very small fraction of the total volume of a system.

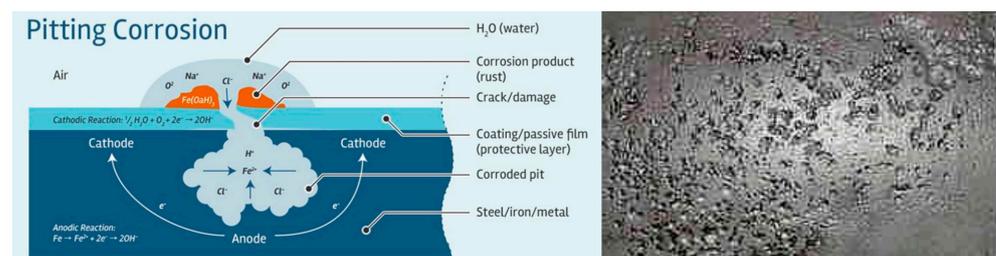
**Figure 5.** Details of the metal surface damaged due to pitting corrosion [104].

Pitting corrosion is a localized form of corrosion by which holes, or cavities, are produced on the metal surface as shown in Figure 5. Because it is more difficult to detect and anticipate, this type of corrosion is more harmful than uniform corrosion damage. Therefore, a small and narrow pit with minimal metal loss can lead to the complete destruction of an engineering system [103].

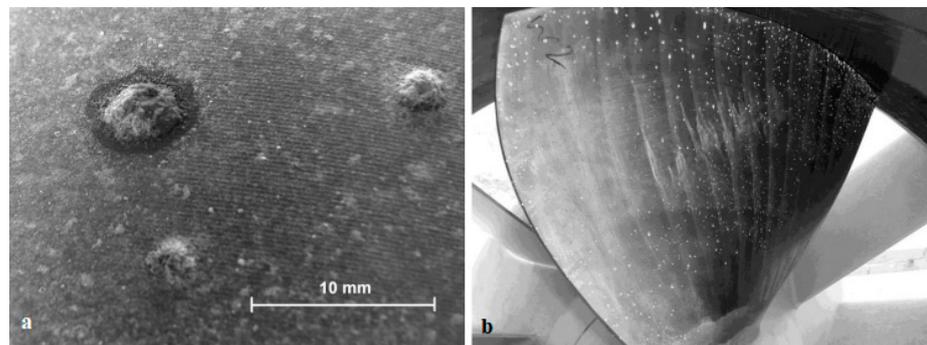
**Figure 6.** (a) The typical pattern of tubercles on a runner and (b) close-up view [106].

forming a block with a shared water intake [106]. In this equipment, the Kaplan-type runner with a diameter of 1.3 m and the runner cap covering the shaft face are made of Nickel Aluminum Bronze (NAB) alloy, means CuAl10Fe5Ni5-C, according to EN 1982 [107]. Additionally, standard austenitic stainless steel 1.4301 is used for the runner ring (X5CrNi 18 10). Corrosion was discovered on most of the runners and runner caps only a few months after the turbines were installed. As shown in Figure 6a, tubercles of corrosion products up to 7 mm in diameter had formed, and there was some material loss beneath them, even though the material met the specification and followed the recommendation related to the ratio of aluminum and nickel content for optimum stability against selective corrosion. Figure 6a depicts the normal tubercle distribution on one of the runner blades, whereas Figure 6b depicts a close-up view. This is despite the fact that the runner rings were not damaged.

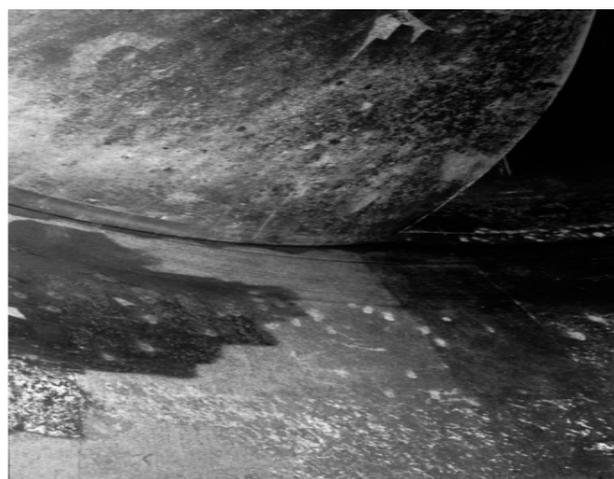
**Figure 7.** Deposits and pitting visible at a turbine blade and the runner ring in a hydroelectric power plant [108].

In another case, after only one and a half years of operation at a sound power plant on the Meuse near Roermond city, the Netherlands, pitting corrosion appeared on the four Kaplan turbine blade surfaces, made of austenitic stainless steels, as illustrated in Figure 7 [108,109]. The most common pitting corrosion causes are cracks in the surface layer, scratches and small chips, non-uniform stress, defective metal substrate, turbulent fluid flow, non-uniform protective coating, and chemical attack on the protective coating. In other words, these are the main causes of failure.

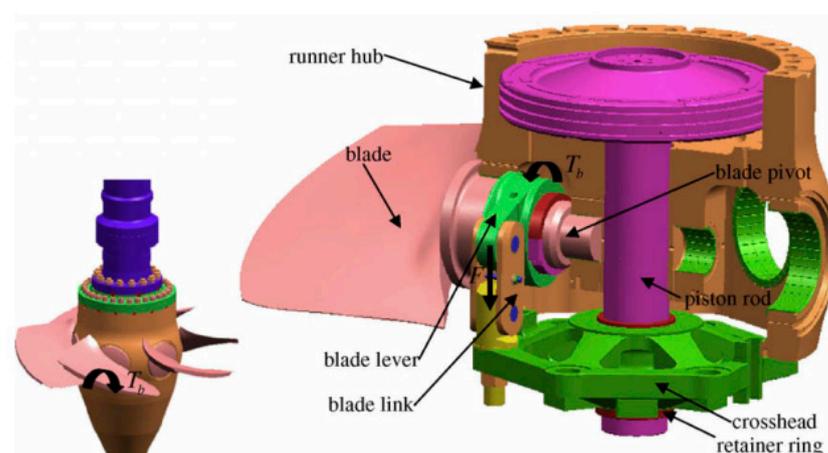
Figure 8. An overview of single blade control system [8].

Kaplan turbines have numerous blades in their runner that can adjust their incidence flow angle to provide good performance at all operating positions. To reach this goal, a complicated control mechanism placed inside the hub and the shaft changes the angle, as shown in Figure 8.

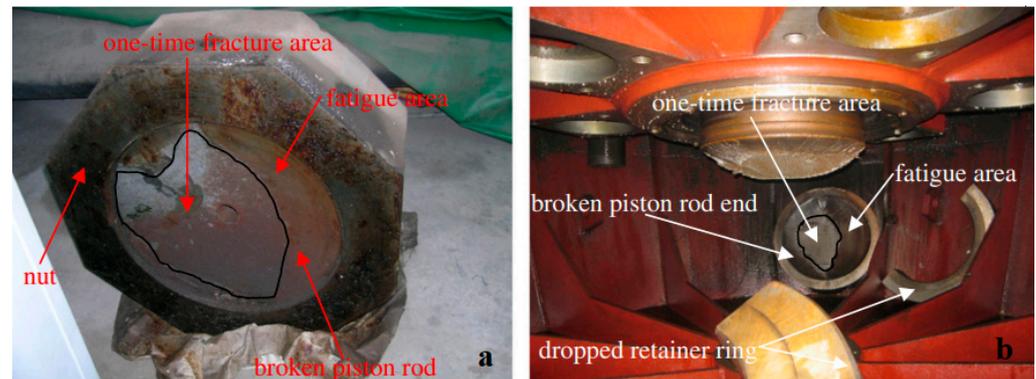
**Figure 9.** Fractured piston rods: (a) nut structure and (b) retainer ring structure [8].

In November 1995, production of a special turbine started: a 204 MW rated output Kaplan turbine ZZA315-LJ-800 moveable propeller with a specific speed of 22.6, an 8 m runner diameter, a 47 m rated head, and a rated speed of 107 rpm at Shuikou hydropower plant (Minjiang river in Fujian province, China). After starting up, the turbine was observed to be badly vibrating on 10 February 2000 [131]. Additionally, the oil level in the oil collection groove decreased greatly. Upon opening the housing, the central axis of the piston rod was found to have broken at the joint of the M540 nut with the crosshead falling into the cone, as shown in Figure 9a.

The nut structure was replaced with a retainer ring structure after the accident, but five years later, on 16 March 2006, the retainer ring structure similarly failed at the same position as that demonstrated in Figure 9b. A comprehensive investigation was performed, including dynamic analysis of position rods to identify the design problem [131]. A detailed analysis of the two cases revealed that the fractured areas exhibited fatigue failure due to cyclic loads. The most probable reason was the blades' unsteady pressure loads. As they convert fluid energy to mechanical energy, the blades are subjected to tremendous hydraulic pressures. The hydraulic pressure on the blades causes torque on the blade pivot, which is transferred to the other parts of the system in the blade-control system. Furthermore, the blade torques are uneven and unsynchronized across the board [8,131].

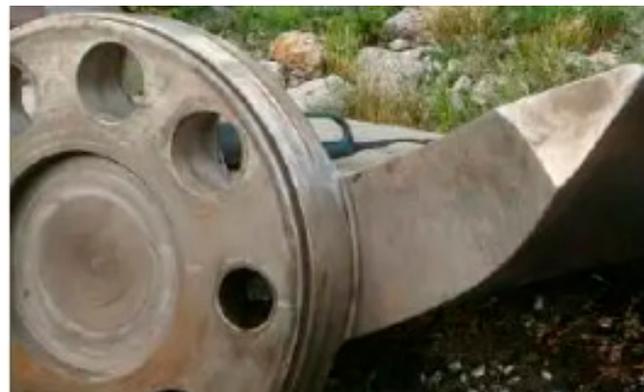
**Figure 10.** The cracked runner blade of a 35.5 MW Kaplan turbine in Romania [132].

Another case of fatigue failure involved a 35.5 MW Kaplan turbine runner blade in Romania. The damage occurred, as shown in Figure 10, in one of the turbines from the hydropower plant's cascade, which worked at a higher head than the others, according to the investigation of the operating conditions [132]. The metallographic observations and calculations conducted led to the conclusion that the cracking of the blade began and developed from the stress concentration located between the blade and the blade flange in the leading-edge direction.

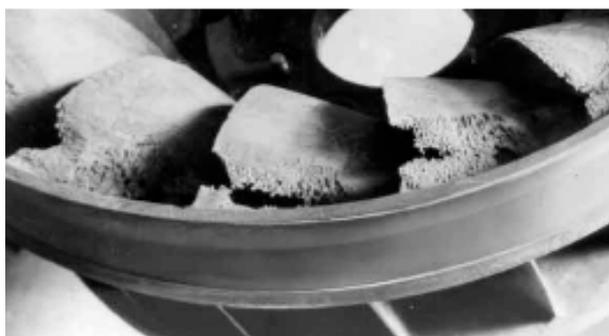
**Figure 11.** Damage in turbine part due to cavitation phenomenon [134].

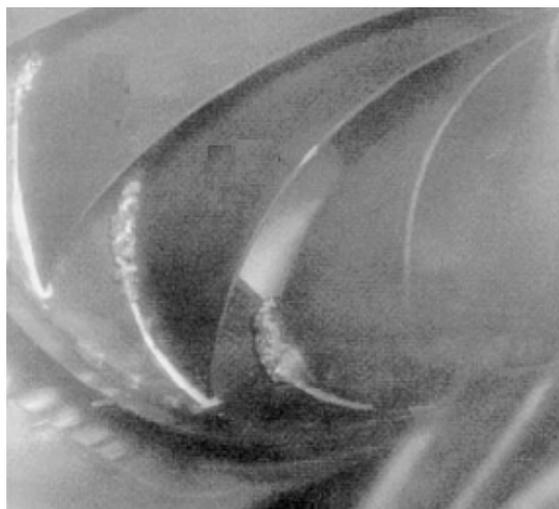
**Figure 12.** Leading-edge cavitation in the Francis turbine [137].

Among the cavitation types that may develop in a flow around a lifting body, so-called attached cavitation or leading-edge cavitation is known to be responsible for severe erosion [136]. It is a very common and complicated type of cavitation that can present different regimes depending on the hydrodynamic conditions. This type of cavitation is usually seen attached to the runner blades' suction side, as shown in Figure 12. They are formed under operating conditions of high head and inflow incidence angles that are significantly larger than the design values. Due to the high-pressure difference between the pressure side and suction side of the runner blade, a leakage flow departs from the high-pressure region to the low-pressure region. The velocity of the leakage flow is particularly high and results in a decrease in pressure at the tip clearance. When the pressure drops below the saturation pressure, tip clearance cavitation generally occurs [18].

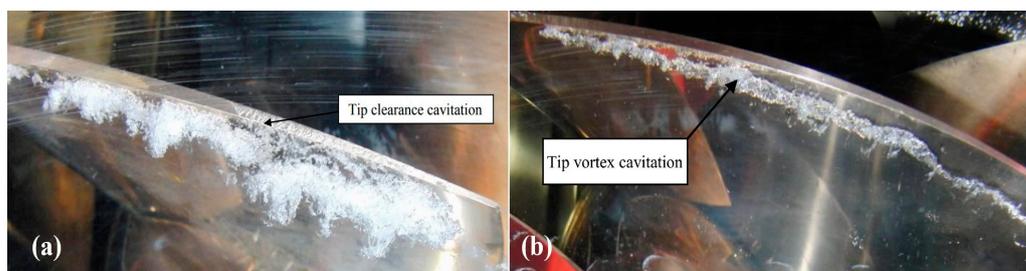
**Figure 13.** Different types of tip-related cavitation, including (a) tip clearance cavitation and (b) tip vortex cavitation [138].

This type of cavitation takes place at the tip of the blade, as shown in Figure 13a. The pressure difference between the intake and suction side of the blade causes flow through the tip clearance. The velocity of the water in the gap could be very high, which is linked to the decrease in pressure. Based on the technical reports of experts in this field and scientific achievements, if the pressure drops below the saturated vapor pressure, a tip clearance cavitation occurs [138]. Another type of cavitation related to tip clearance is called tip vortex cavitation. When the tip clearance flow leaves the gap, a jet is created. The jet leaves the suction side of the runner blade and creates the tip vortex. The tip vortex begins near the blade's leading edge, detaches the suction side surface of the blade, and continues downstream along the runner blade as shown in Figure 13b.

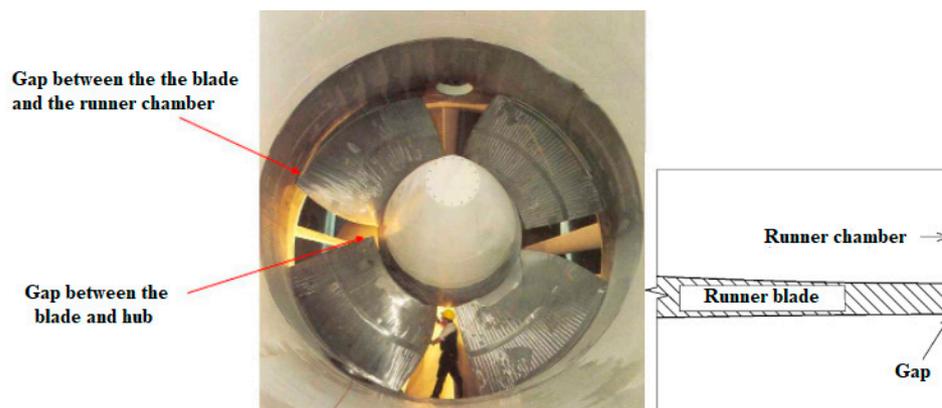
**Figure 14.** Gap between the runner blade and the runner chamber [138].

The Kaplan turbine's optimal operation is ensured by a twin regulation mechanism. On-cam operation is possible because of the adjustable distributor and runner blade openings. The runner is not shrouded since the runner blades are changeable. This indicates that there is a space between the revolving hub with the blades and the stationary runner chamber [138]. Space is also known as a "tip clearance" (see Figure 14). In this regard, scientists have investigated the tip-leaking vortex that forms in the clearance between the rotor and the stator of axial hydro turbines. However, many related phenomena remain unknown. For example, it is still unknown how the clearance size relates to the incidence of cavitation in the vortex, which can cause severe erosion and damage to turbine blade [139].

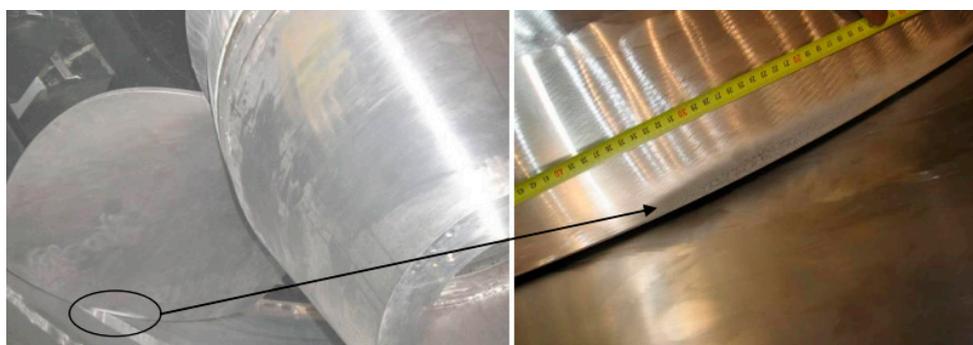
**Figure 15.** Cavitation pitting on the suction side of the blade near the runner chamber [138], the right image shows the part highlighted in the left one with higher magnification.

A cavitation was identified at a 10 MW rated power and 10 m water head Kaplan turbine. The dimensions of the cavitation were approximately  $200 \times 20$  mm with a maximal depth of 3 mm located at the suction side of the blade near the runner chamber, as demonstrated in Figure 15. The CFD analysis revealed the presence of a tip vortex with a specific shape and intensity, which might generate cavitation pitting in the same location as the prototype.

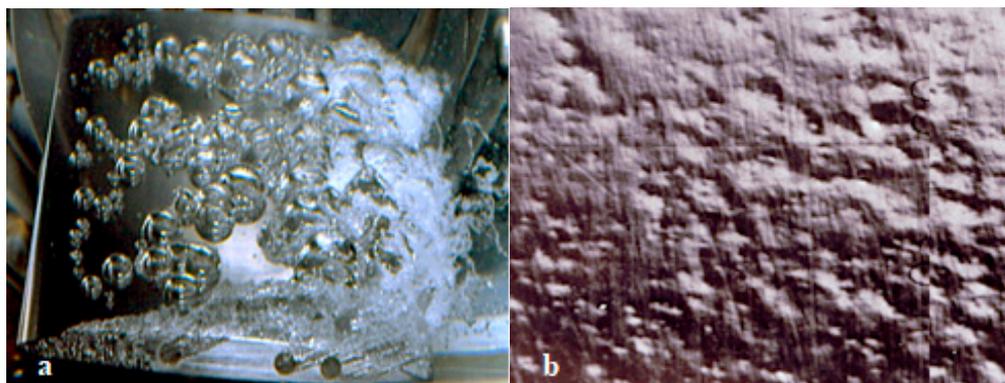
**Figure 16.** (a) Traveling bubble cavitation and (b) pit overlap and damage due to bubble cavitation [141].

This type of cavitation appears in the form of bubbles that move along the solid body. When the bubbles reach the vicinity of the low-pressure point, they become visible [140]. It takes the form of separated bubbles attached to the blade's suction side near the mid-chord next to the trailing edge, as shown in Figure 16a. On the suction side of the blades, traveling bubble cavitation can be seen at the rated discharge. This is a severe and noisy type of cavitation that significantly reduces the machine's efficiency and that can provoke erosion if the bubbles collapse on the blade [138,140]. Traveling bubble cavitation depends upon the water quality. As shown in Figure 16b, each cavitation bubble may leave a pit on the wall as it collapses.

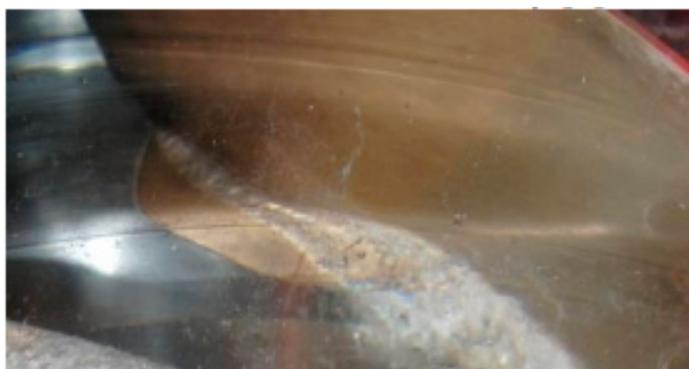
**Figure 17.** Extension of hub cavitation around the Kaplan turbine [144].

This is a sub-category of vortex cavitation [143]. It is observed in the central parts of vortices gyrating away from the liquid flow around the obstacle. The hub vortex cavitation is usually due to a high angle of incidence between the direction of water flow and the blade's leading edge. It can result in the outer edge of the blade looking a bit moth-eaten. Because of the designed operating range, it usually appears at the runner's hub, as seen in Figure 17.

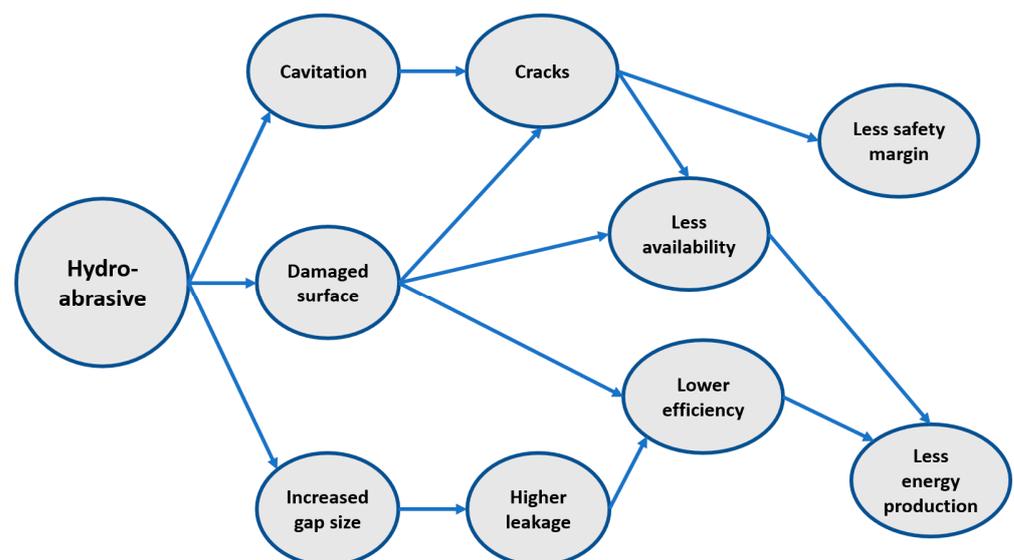
**Figure 18.** Hydro-abrasive effects on hydro turbines.

The flow of sediment particles in rivers is a major challenge for developing hydropower plants across sediment-laden rivers. Hard particles such as quartz and feldspar can be found in abundance in rivers around the world. The abrasive effects of these particles cause damage in hydro turbines, particularly in high- and medium-head hydroelectric power plants. Due to maintenance expenses and output losses, this has become a severe economic issue [147]. Hydro-abrasiveness is due to suspended sediments in the water that pass through the turbine, and depending on the impact conditions, the particles, which are harder than the surface material of the turbine parts, damage the surface. The surface material is worn away, resulting in geometric changes and efficiency loss, cavitation and mechanical problems, higher maintenance costs, less availability, and loss in energy production. Figure 18 depicts the above-mentioned cases. Abrasion in hydro turbine components is complicated, and it is governed by several factors: (1) eroding particle properties such as concentration, size, shape, hardness, mineral constituent proportion, and toughness, all of which have a direct impact on turbine material; (2) turbine base material; and (3) operating conditions such as velocity and impingement angle [4,5].

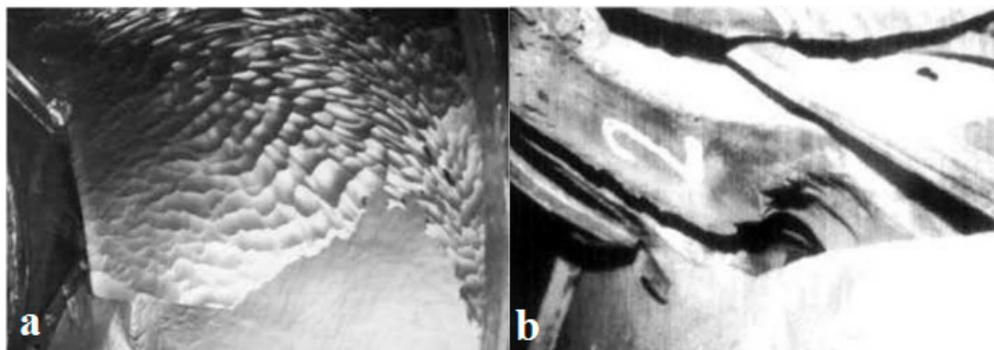
**Figure 19.** Extensive abrasion on Kaplan turbine components, including (a) runner blade and (b) guide vanes [148].

head regulator located 5 km downstream of Rishikesh town. Turbine components have been exposed to severe abrasion and erosion since the power plant was opened [148]. The high concentration and large size of silt particles from the Ganga cause extensive damage to the underwater parts of hydro turbine units, cooler tubes, drainage pump impellers, and valve seats. In the early years of operation, the blades of the Kaplan turbine were found to be extremely eroded and cracked on the trailing side after a few monsoon seasons [148]. Figure 19 shows extensive abrasion on the runner blades and guide vanes, which require heavy maintenance and major repairs.

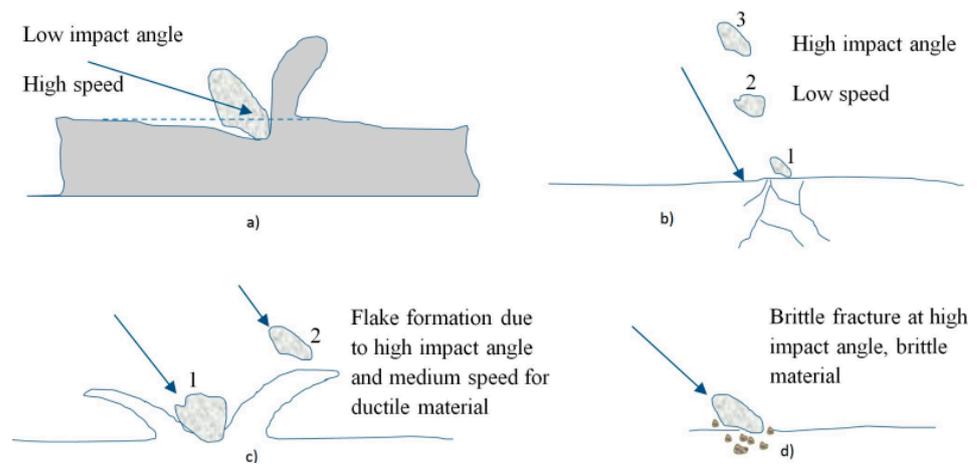
**Figure 20.** Various forms of erosive wear mechanisms, including (a) abrasive/cutting erosion, (b) fatigue erosion, (c) plastic deformation, and (d) brittle fracture [154].

Erosion can be classified under one of several types of wear caused by the impacts of solid and liquid particles on a solid surface. In fact, the flow contains particles that have enough kinetic energy to corrode the metallic surface. The mechanism of erosive wear is quite similar to that of abrasive wear, but in the case of abrasive wear, the eroding agent is much larger in size and the contact angle is smaller [28]. Surface roughening is the initial stage of erosion followed by pit formation. This leads to a significant reduction in the weight of the material [17]. In addition, the surface damaged by erosion makes the condition favorable for cavitation, which means a coalesced effect [15]. Weight loss in turbine components due to erosion depends on the load of particles entering the power plant. Two distinct erosion mechanisms arise from the impingement angle of a particle on the hydraulic surface. Impact damage occurs when a particle approaches the normal surface, causing the surface to crack at first, then loosen with repeated impacts, and finally excavate, as the surface is already cracked and loosened by the particle and removed by another impacting particle. Additionally, similar to mechanical grinding, a particle approaching parallel to the surface would scratch and gouge the surface [149–151]. Erosion damage is commonly defined as the slow disappearance of material produced by repeated deformation and cutting activities [152]. When particles strike the surface at a small impingement angle, the material is removed by the cutting mechanism [153] as shown in Figure 20 [154]. Moreover, the abrasive grits roll and slide when they strike on the surface at a small impingement angle and cause erosion by abrasion or cutting mechanism [154–156].

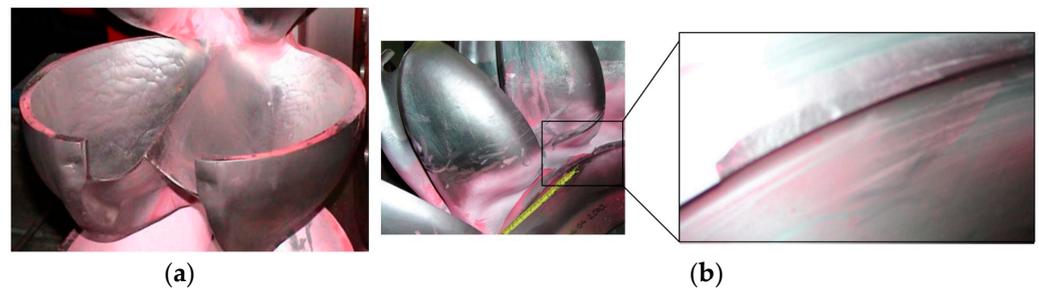
**Figure 21.** Sediment erosion in different parts of hydro turbines, including (a) surface erosion Pelton runner [158] and (b) damage to runner disk [159].

Various studies have been performed in each of the above mechanisms. Overall results show that the average velocity of particles, their mass, the concentration of abrasive particles in fluid, the size distribution of particles and their average grain size, the shape of the particles, the angle of impingement, the time interval of the attack, and the erosion resistance of structural material all influence the erosion damage process [157]. Silt erosion is designated as abrasive wear. This type of wear breaks down the oxide layer on the flow guiding surfaces and partly makes the surfaces uneven, which may also be the origin of cavitation erosion (see Figure 21).

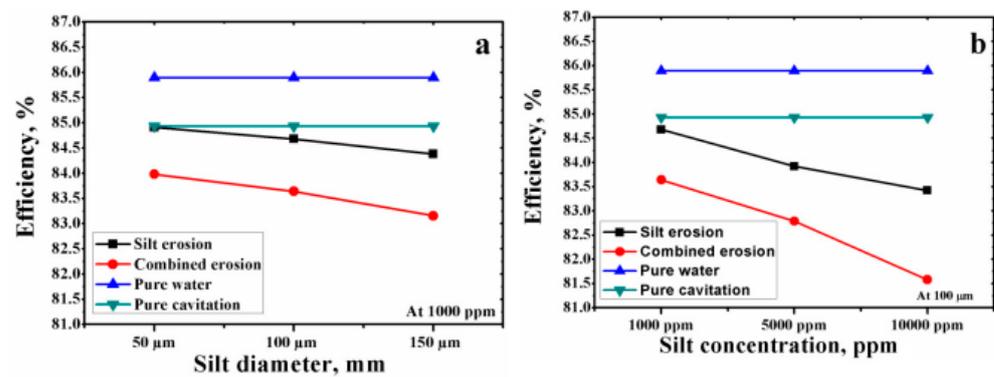
**Figure 22.** Efficiency trend of software modifications under pure water, cavitation erosion, silt erosion, and combined erosion at various silt parameters, including (a) silt size and (b) silt concentration [160].

Dinesh and Bhingole have calculated the efficiency of the Kaplan turbine considering different flow conditions such as particle size and silt concentration [160]. In this regard, overall efficiency of software modifications under pure water, cavitation erosion, silt erosion, and combined erosion at various silt parameters is demonstrated in Figure 22. In pure water flow, turbine efficiency is about 85.90% at full opening of the wicket gate. Moreover, in cavitation erosion operation conditions, the efficiency is reduced by 0.96% compared with that of pure water flow. Additionally, the efficiency of silt erosion operations decreases as the silt parameter increases. In this case, maximum efficiency drops of 2.47 pct were observed at a silt diameter of 100  $\mu\text{m}$  and a silt concentration of 10,000 ppm. However, in combined erosion, the operation efficiency is drastically reduced compared with the other operation conditions. In combined flow with the same silt parameter, the maximum efficiency drop was 4.31%.

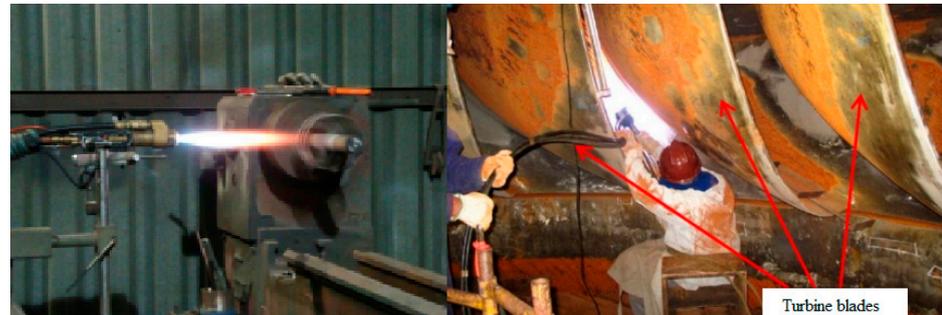
**Figure 23.** Alloy coatings deposited by the HVOF process [178].

spraying technologies such as detonation guns, plasma spraying, High Velocity Oxy-Fuel spraying, and cold spraying have already been used commercially on various equipment components [179]. Due to their combination of excellent toughness and high hardness, which are required for corrosion and mechanical wear resistance, the deposition of carbide coatings by the HVOF thermal spray process has been widely discussed in the literature and applied in the industry, as shown in Figure 23.
